**FERGANA VALLEY
CANAL AUTOMATION PROJECT**

**REPORT OF THE THIRD MISSION
OF INTERNATIONAL EXPERTS**

May 10-27, 2008

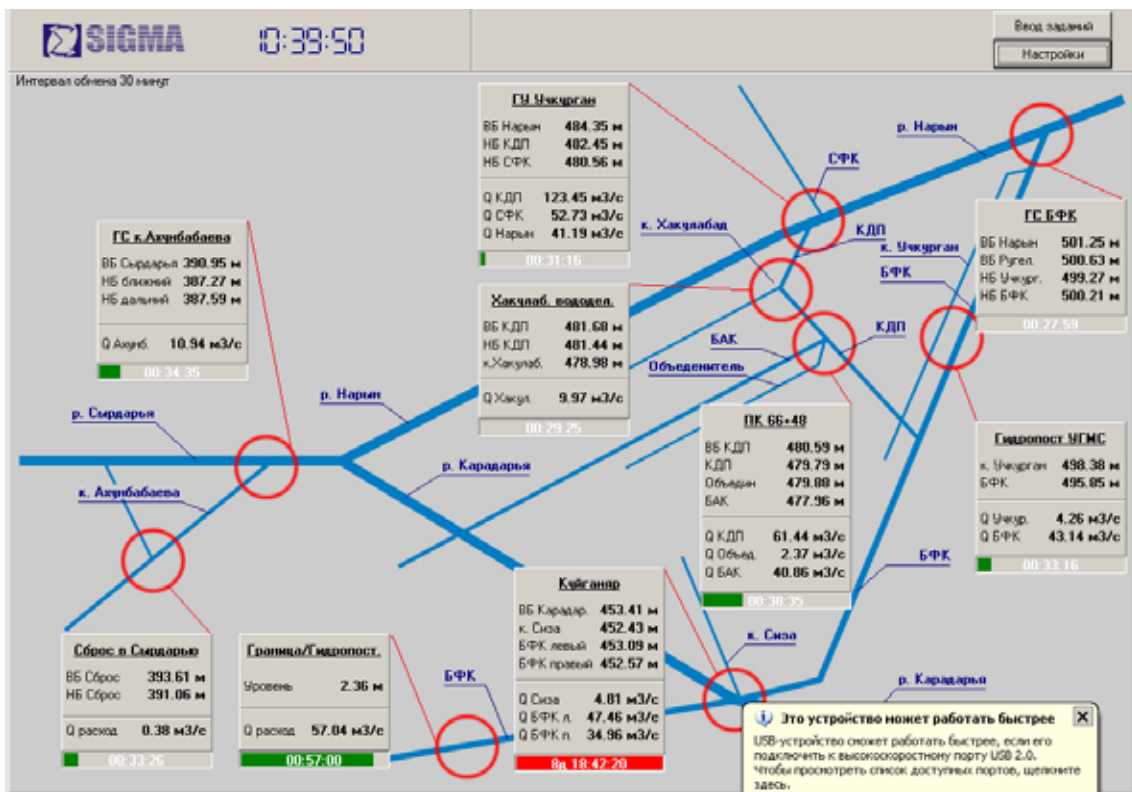
Figure 1: Snapshot of levels and discharges in the BWO/Syr Darya structures on May 21, 2008

For each structure, the time below the measurements indicates the time elapsed since last update (Kuyganyar in red has permanent communication problems). This chart illustrates the low values of discharges in the whole system.

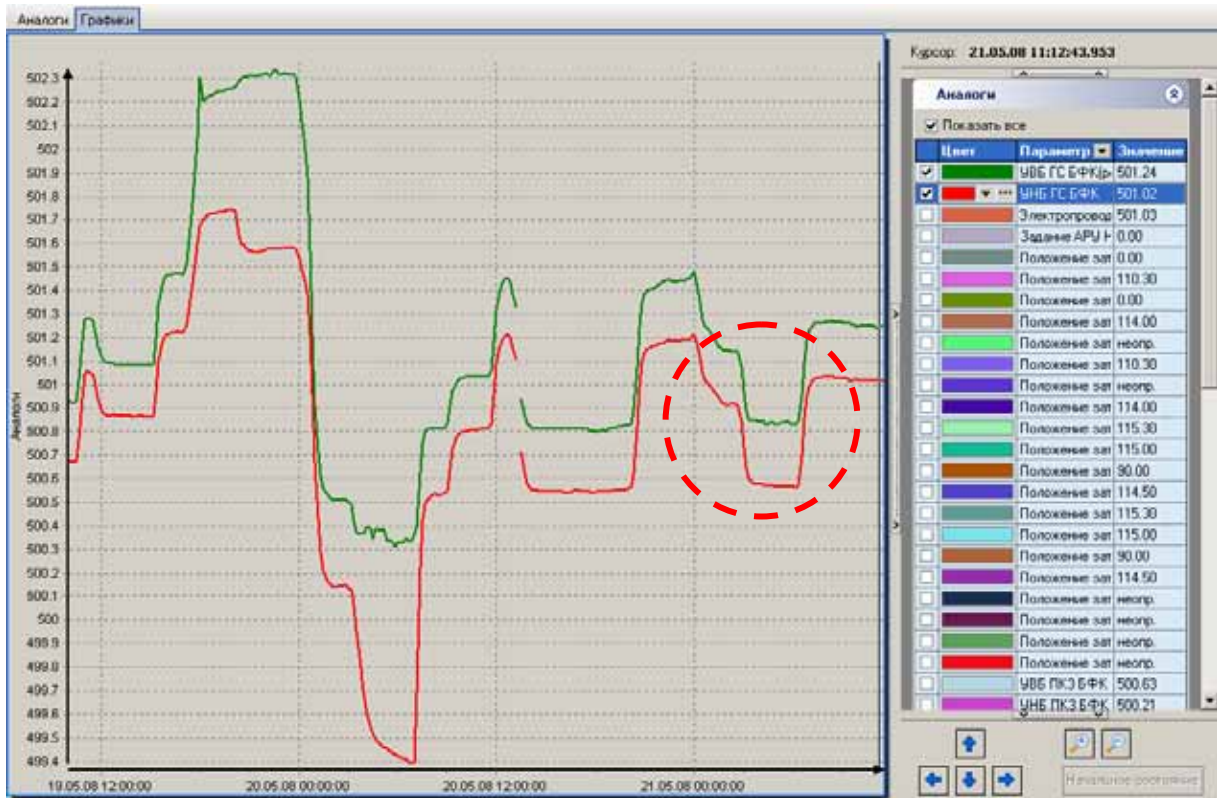
- 1) Important variations of the level of Naryn river: large variations of the level of the Naryn River are observed on a daily basis (see Figure 3 and Figure 4 in Appendix). This problem was not felt with such importance in earlier years. As a consequence, the automatic regulation mode of the BFC head works cannot be used when the level is too low. Moreover, water can drop to a level too low to be measured by the ultrasonic level sensor located upstream of BFC head works. In these conditions level measurements have to be performed manually.

Figure 3: Variations of the level at BFC head works on Naryn River over a 2-day period

The chart shows the river level upstream of the structure (green), the level downstream the structure (red). The river bed is at elevation 500. Every day, an important decrease of level is observed early morning (see detail below), and also sometimes in the afternoon.

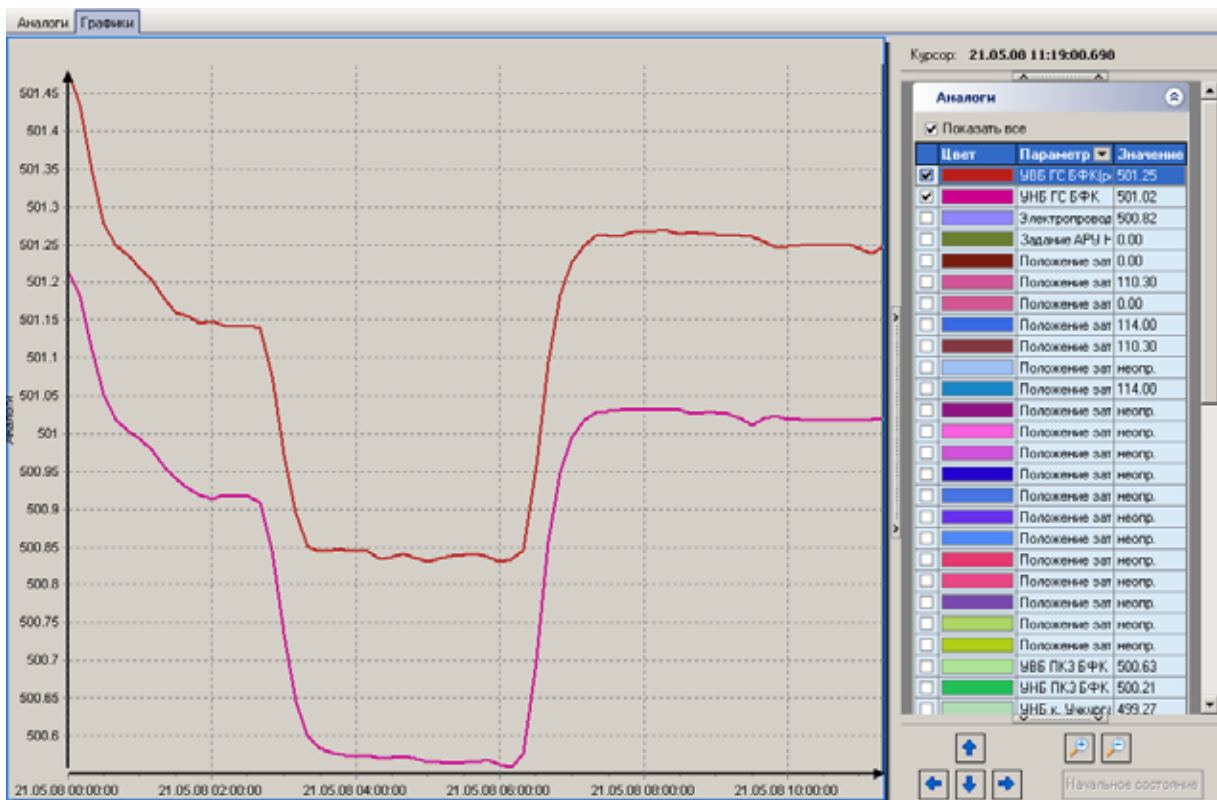
Figure 4: Variations of the level at BFC head works on Naryn River – detail of previous chart.

The chart shows the river level upstream of the structure (dark red, above), the level downstream the structure (pink, below).

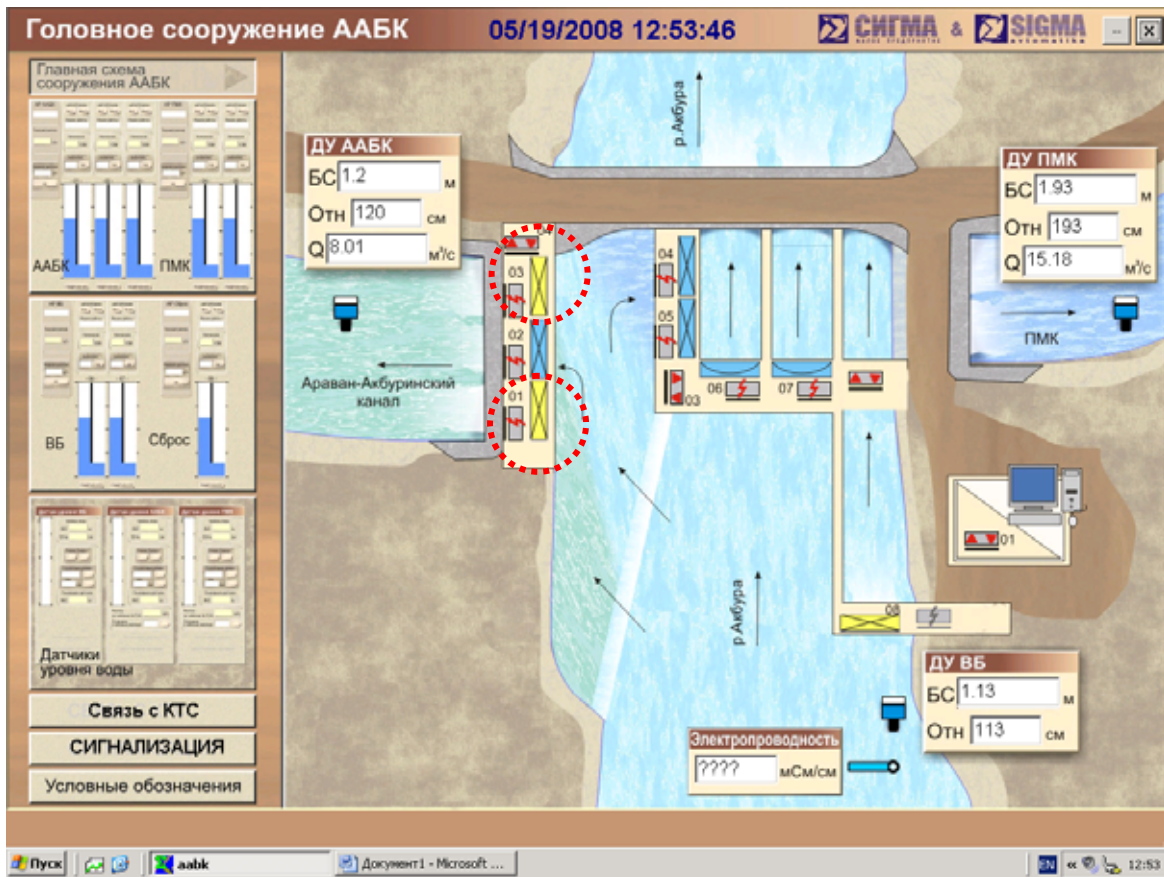
- Two out of the three gates at the head of the AAB canal can only be operated manually. The causes of the defects will be investigated and repairs done by AAB administration.
- There are frequent power cuts causing interruption of the supervisory control.
- Further training of operators by SIGMA is needed.

Figure 8 Head Work Screen Display

The two dotted circles indicate the gates which can only be operated manually.

SDC strongly recommends that AAB Administration proceeds with the repair of the two gates and purchases diesel generators, or solar panels if socially acceptable, to keep the SCADA system under operation.

- The two gates of AABC head work which are not working must be repaired, and actions for avoiding such default have to be taken. Regular maintenance of all equipments must be done. The best solution is to have a contract with a private company, as it was done with SIGMA on BWO structures.
- Actions have to be taken for avoiding loss of data in case of power cut. It is recommended to install a backup power supply, either by diesel generator or by solar panels and batteries; only measurements and data transmission have to be backed up and require limited power.
- It is recommended to extend the assistance of SIC and SIGMA to AABC to provide an efficient on-the-job training to the operators; an additional session of practical training could also be organized on site as quickly as possible.

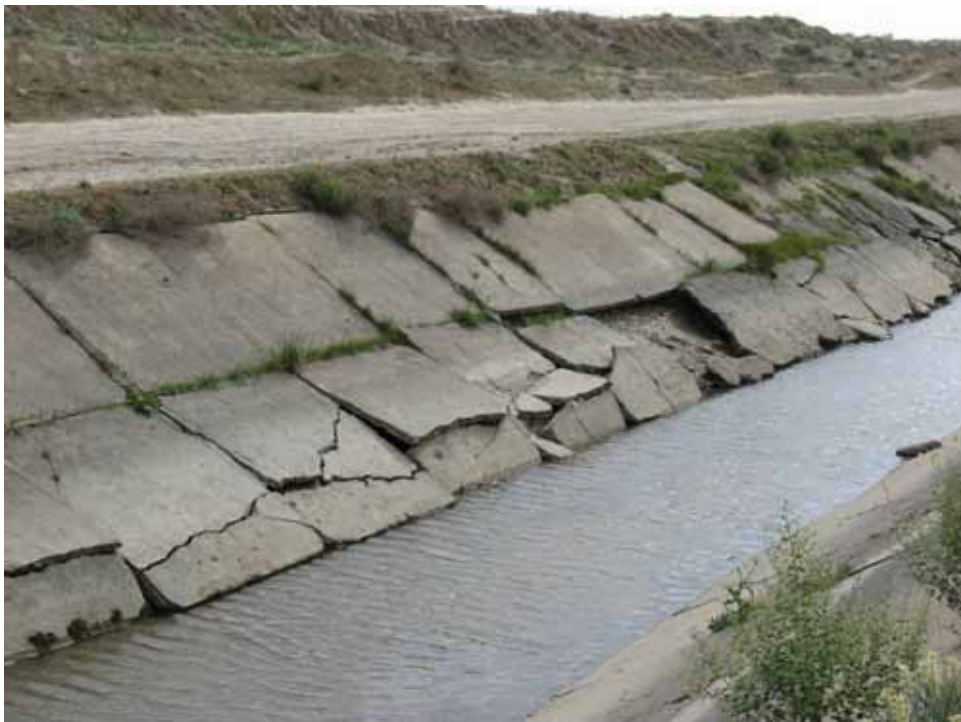
The main canal was concrete-lined over its entire length, with the exception of the upstream 3 km. Considerable damages to canal lining were observed during the field visit, mostly on the left hand side, which is characterized by a bank at a higher elevation. The damages to the concrete panels, such as sliding and horizontal breaks are typical of the damages caused by cycles of frost and thawing. The repetitive cycles of filling and draining of canals due to the

Damaged canal lining at point 4

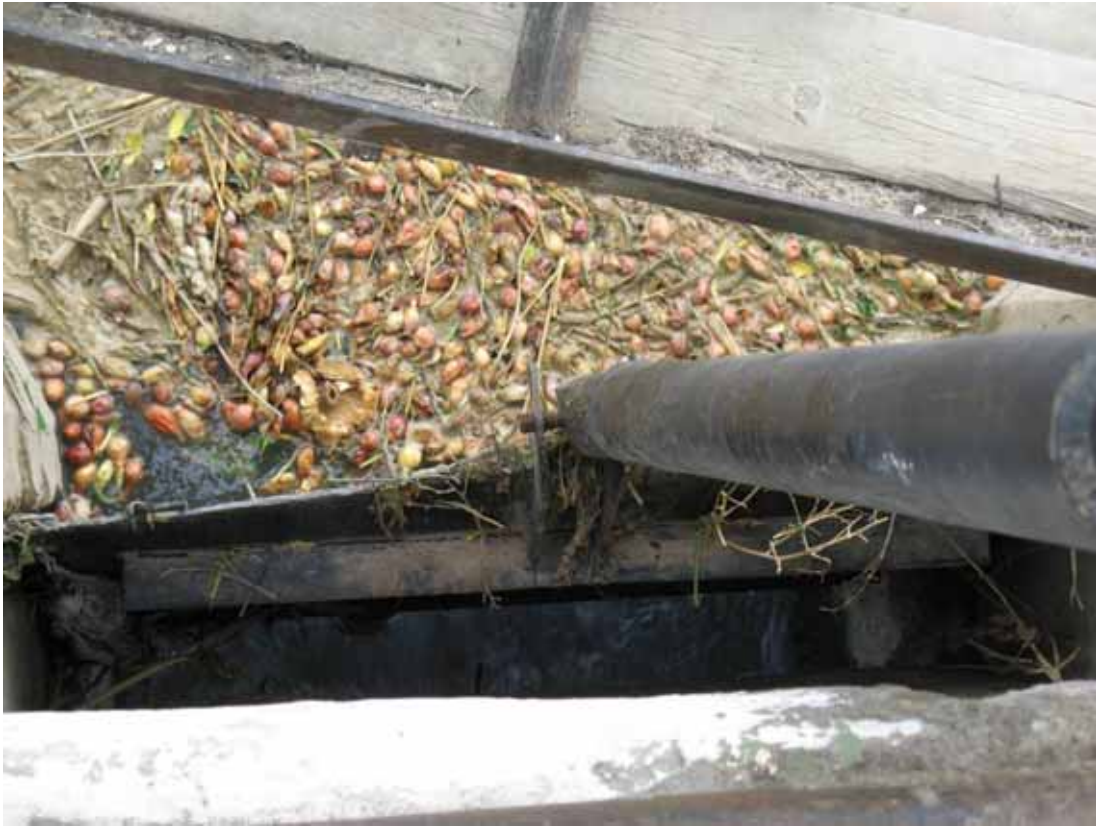
- broken casing of reducer was also observed (e.g. point 3),
 - some reducers were found missing (e.g. point 5).
- Condition of the gates:
 - in many cases, the thickness of the gates did not seem appropriate to their size or their use, resulting in gates bent after operation (e.g. point 6, point 5),

Bent gate at point 6

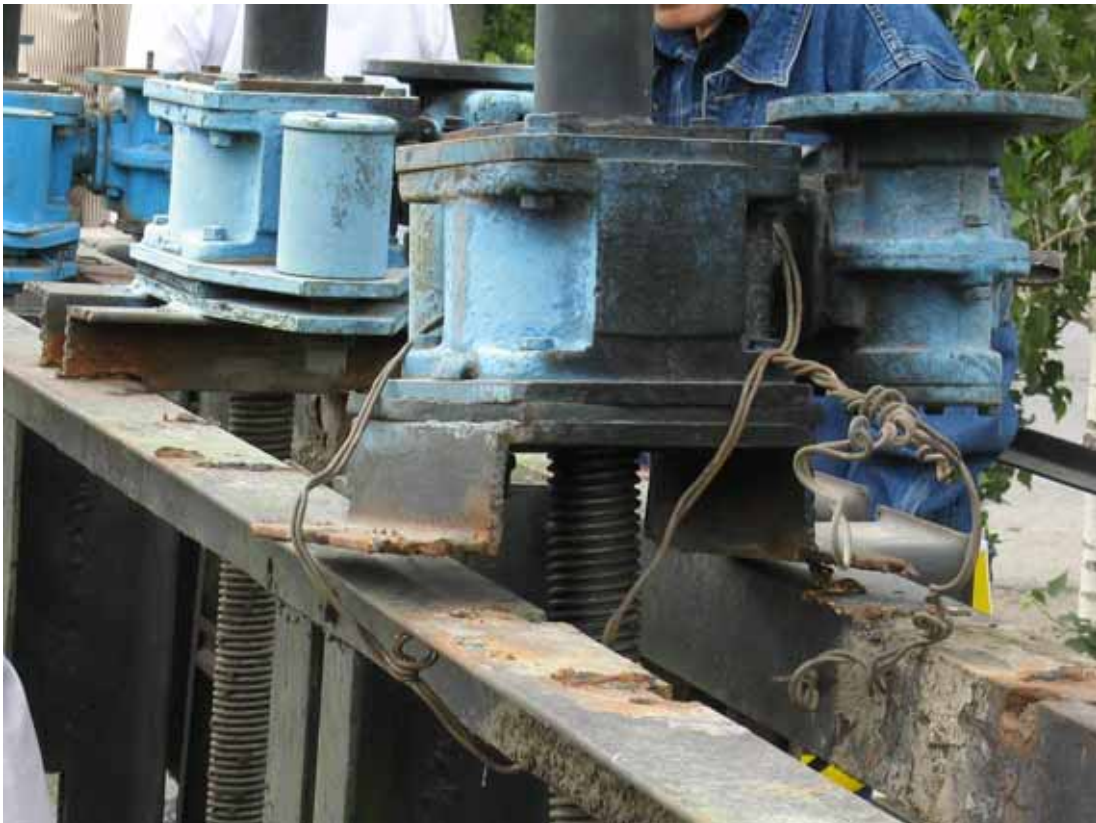
- welding of the reducers to the gate frames is weak in most cases (welding by irregular points and not on the whole perimeter of reducer) and was found broken at several occasions (e.g. point 6),

Broken reducer support at point 6

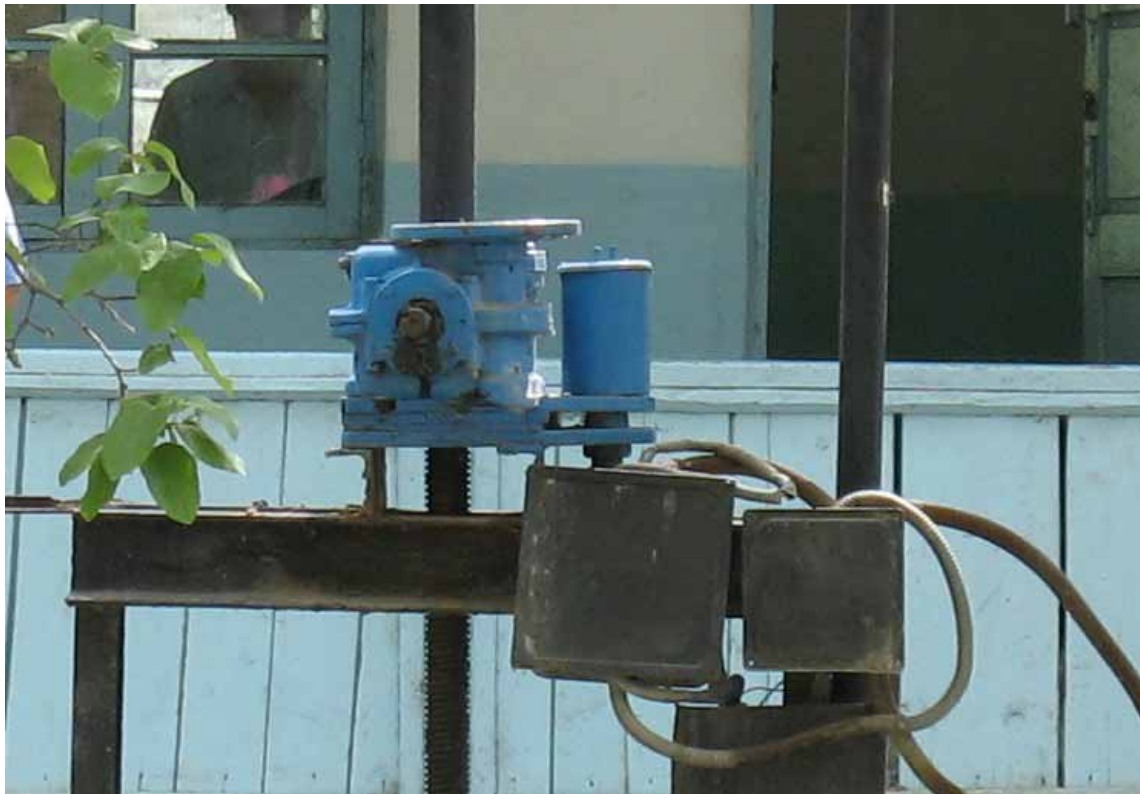
- the gates screws were found several cases non vertical (e.g. point 4, point 6), possibly due to bad execution of installation and welding of reducers.

Non-horizontal reducer at point 6

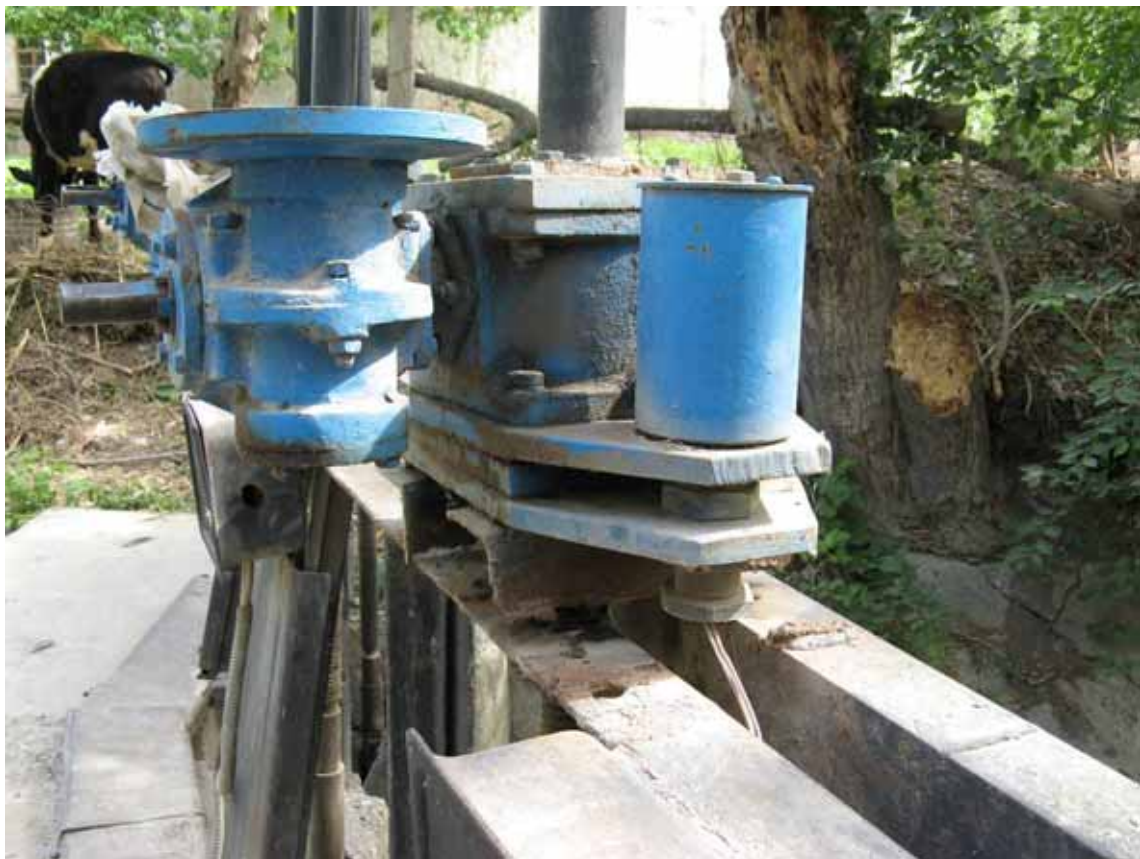
Broken reducer support at point 6

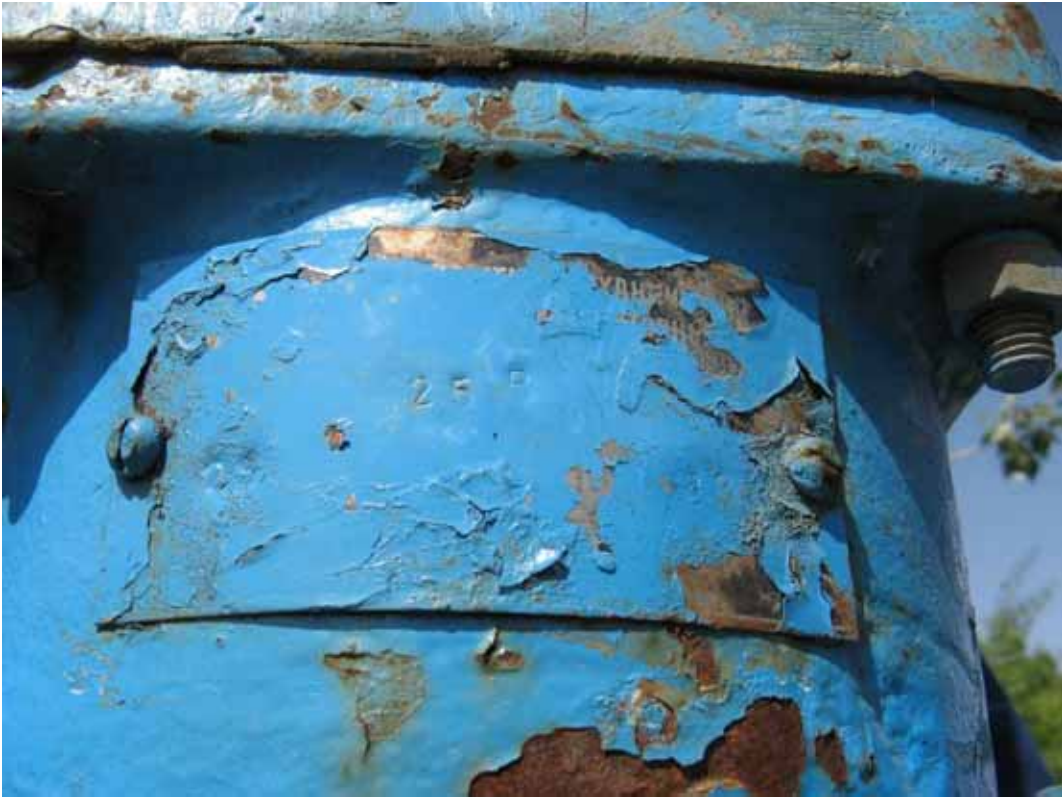
- Condition of the reducers:
 - some reducers could not be operated, some others did not operate smoothly (e.g. point 2),
 - most of the reducers are not in good condition, considering they were recently installed; (e.g. point 6),

Bad condition of reducer at point 6

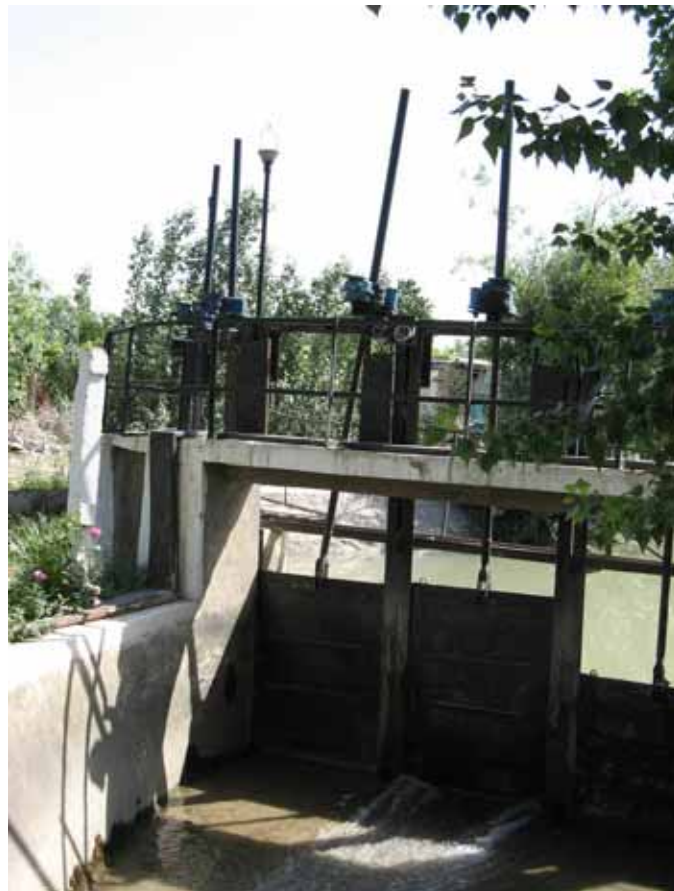
Broken reducer support at point 6

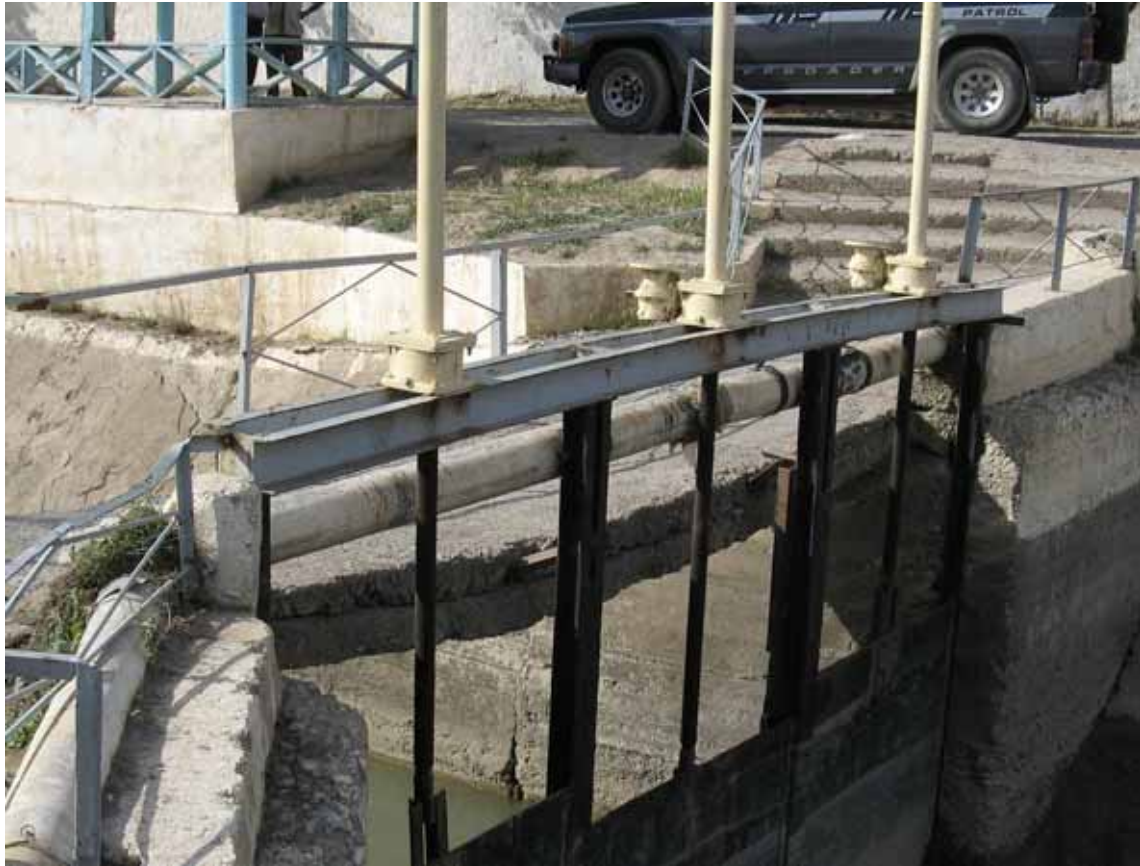
Missing reducers at point 5

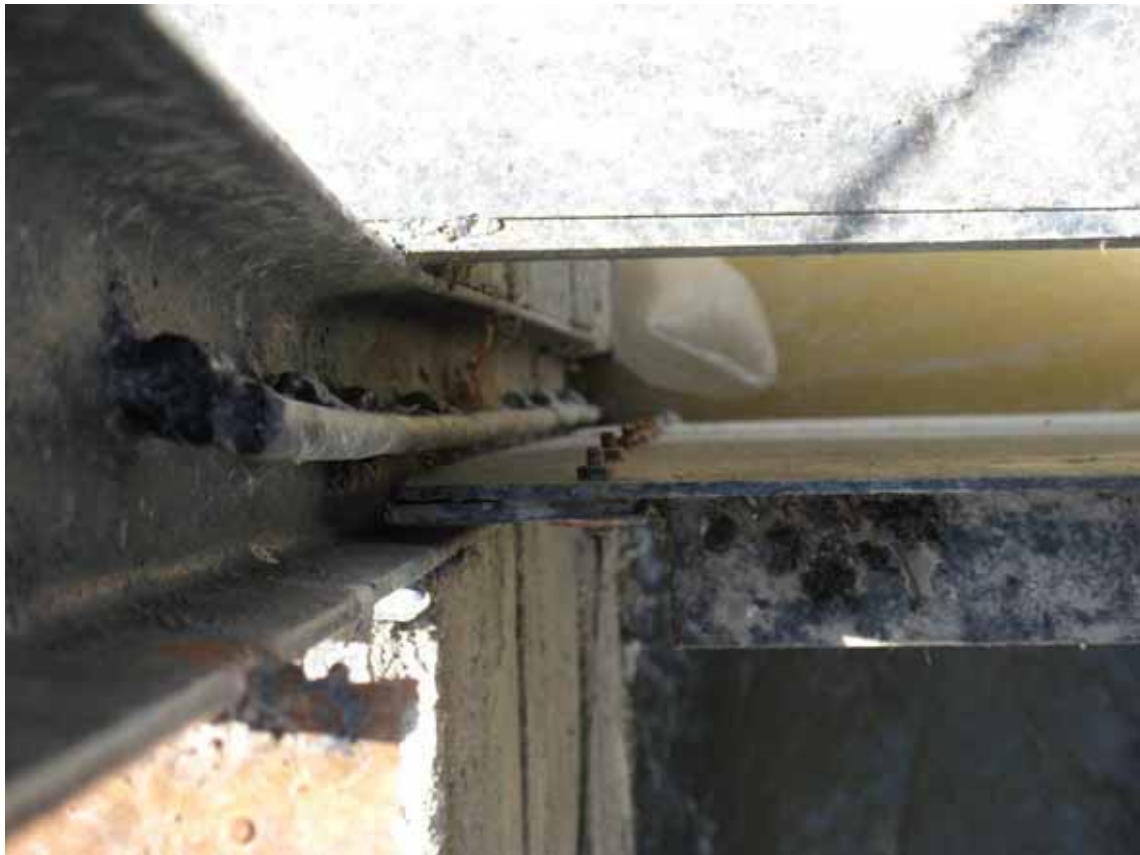
Guiding of gate at point 3

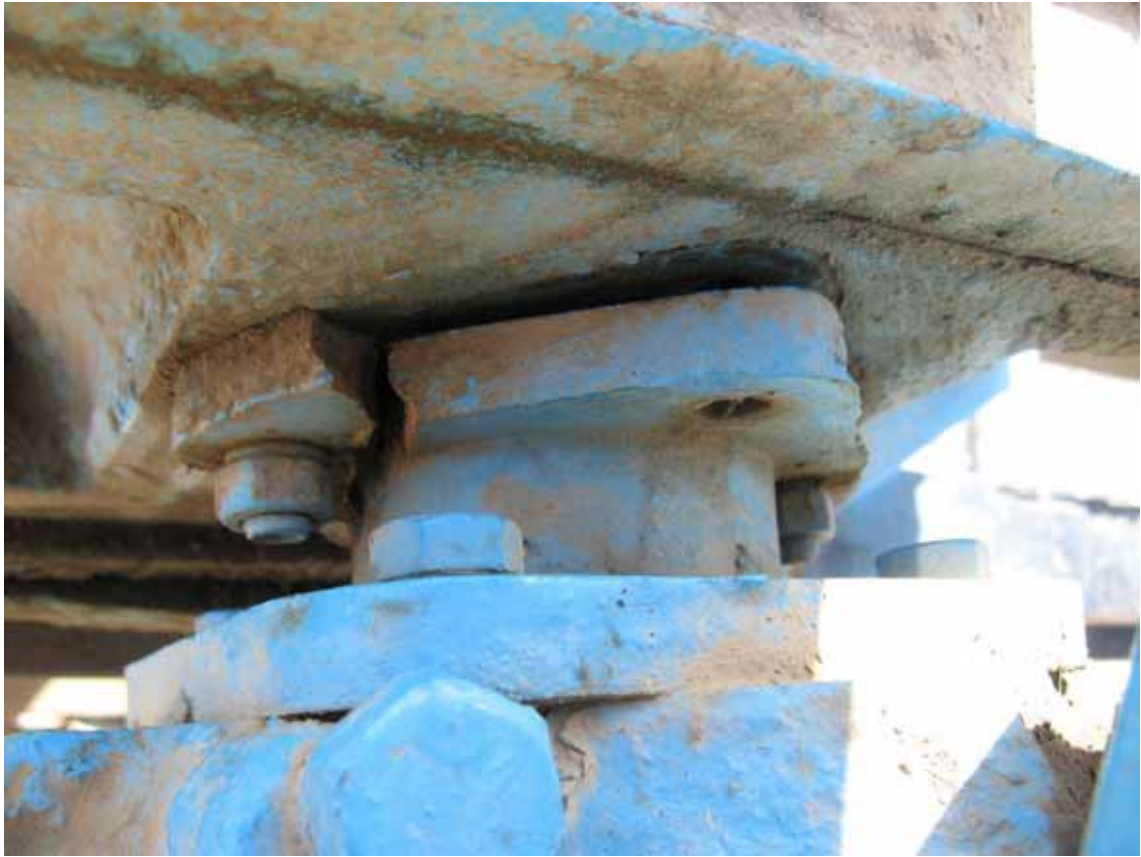
Broken reducer casing at point 3

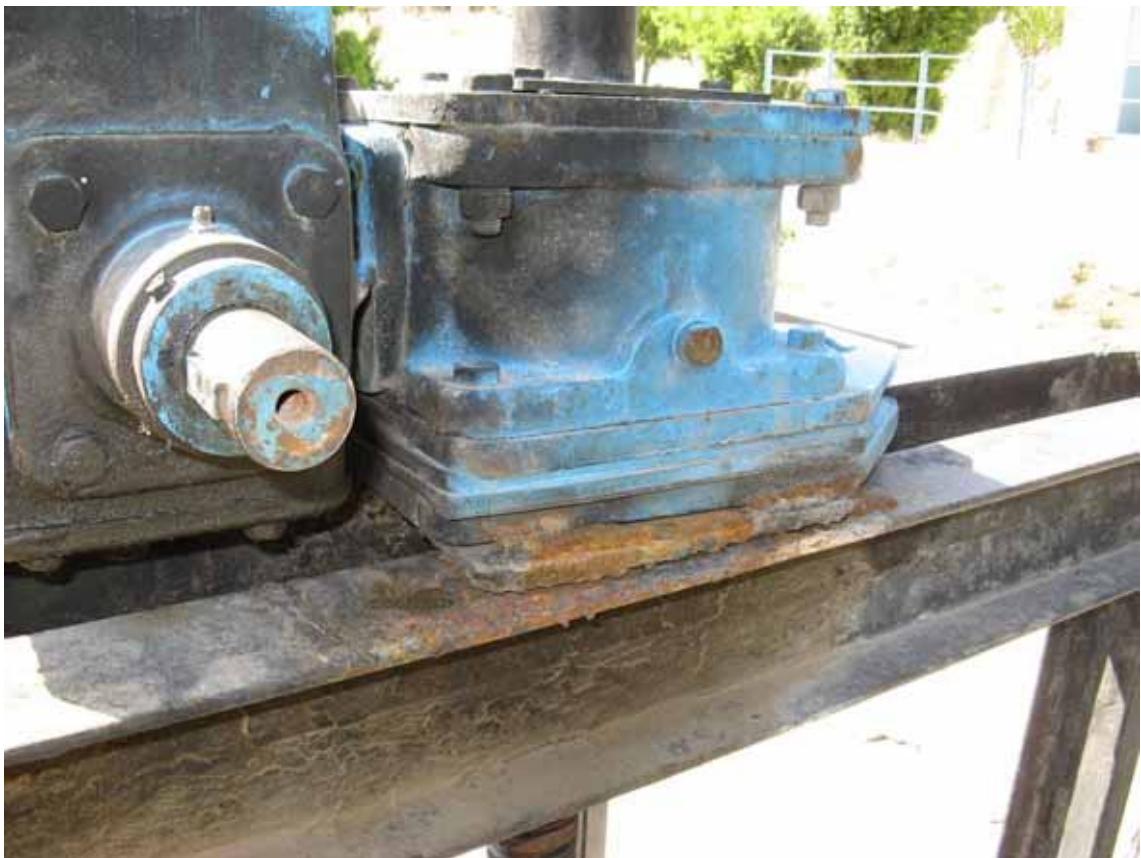
Broken reducer welding at point 2
