**FERGANA VALLEY
CANAL AUTOMATION PROJECT**

**REPORT OF THE THIRD MISSION
OF INTERNATIONAL EXPERTS**

May 10-27, 2008

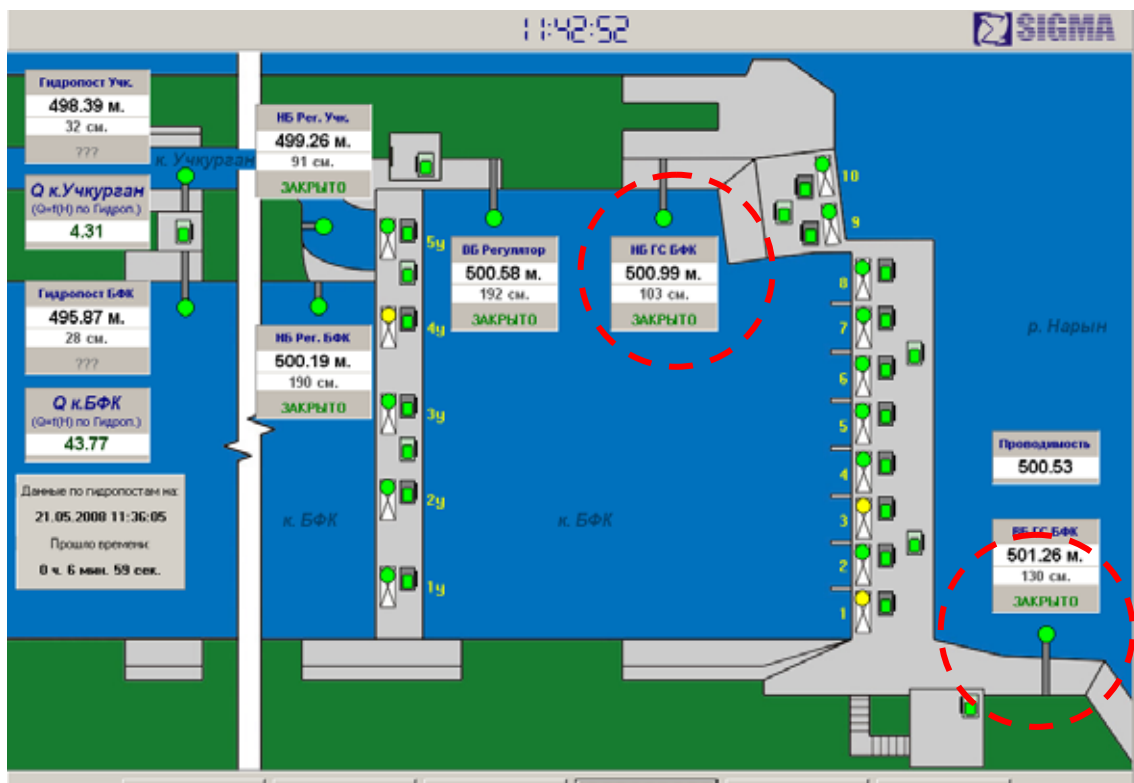
Figure 1: Snapshot of levels and discharges in the BWO/Syr Darya structures on May 21, 2008

For each structure, the time below the measurements indicates the time elapsed since last update (Kuyganyar in red has permanent communication problems). This chart illustrates the low values of discharges in the whole system.

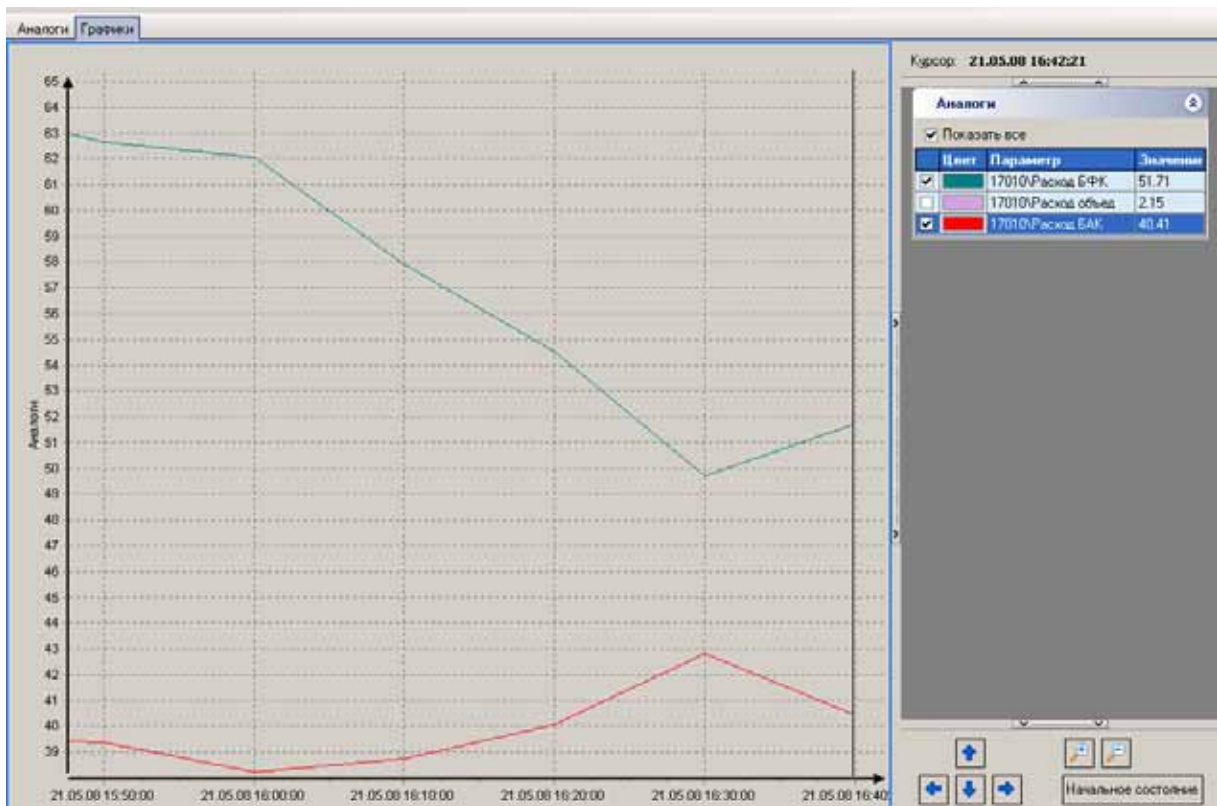
Figure 5: Location of discharges changed during test at DP66

Test of control of gates from SCADA system: At DP15, a test was performed consisting in reducing the offtake discharge from 14,3 to 13 m³/s. Another test was performed at DP66: discharge on BFC was reduced and discharge on BAC was increased of the same value (see Figure 6). Both tests gave the expected result and control of gates seems to be operating properly.
